7 **MARGUERITE DAM**

3 NDI ID NO. PA-455

6 PHASE I INSPECTION REPORT  
NATIONAL DAM INSPECTION PROGRAM

Prepared By  
**L. ROBERT KIMBALL & ASSOCIATES**  
CONSULTING ENGINEERS & ARCHITECTS  
EBENSBURG, PENNSYLVANIA  
15931

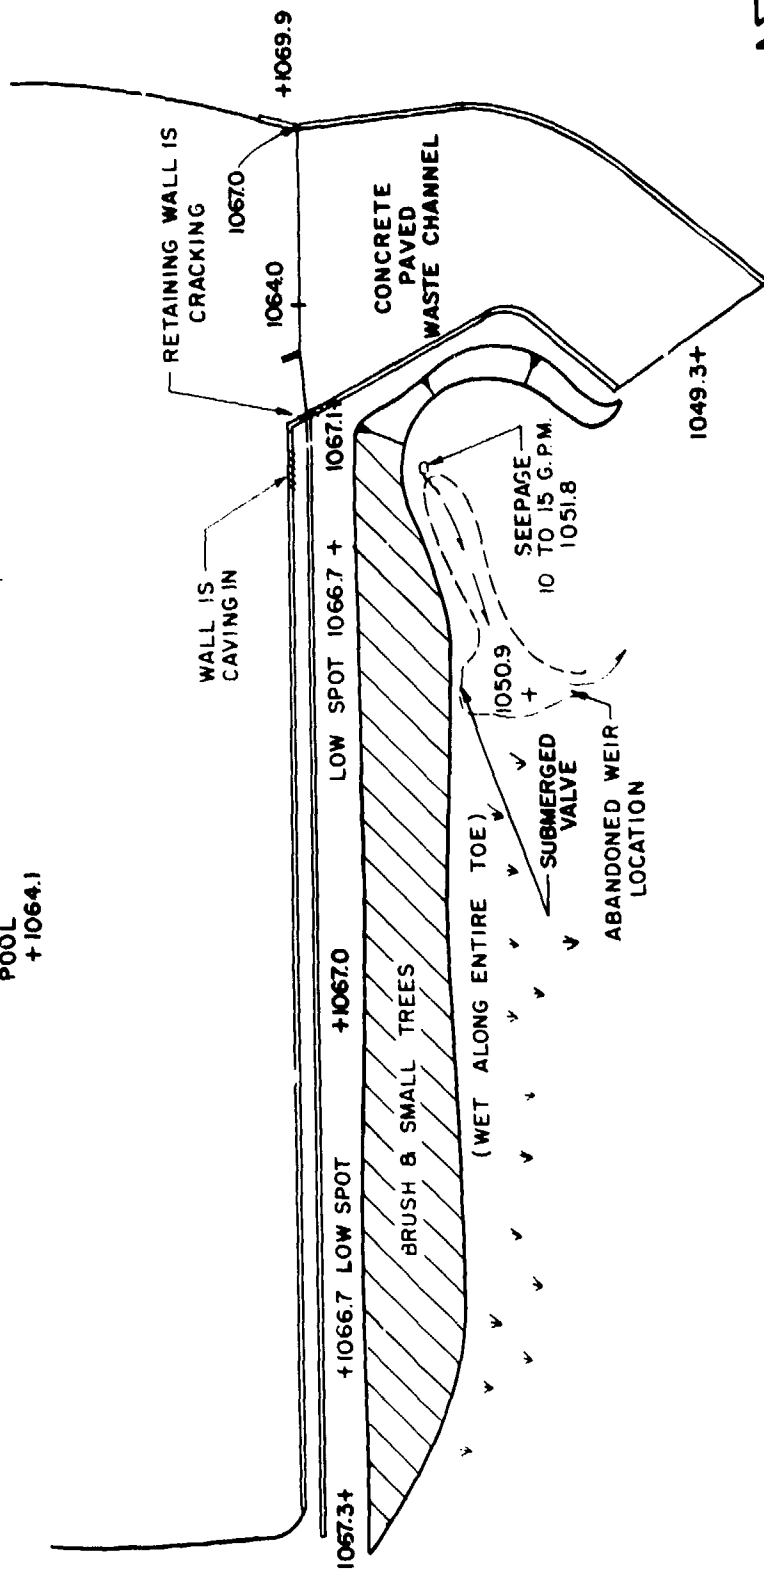
MARGUERITE DAM  
SCALE: 1" = 40'

The low spot elevations on the crest of the dam were determined to be at elevation 1066.7, based on a survey conducted during the inspection. The low spots are located at approximately either end of the earthen embankment section. The location of the low spots can be observed on the planview drawing, located in Appendix A of this report (See Appendix A, A-12).
